Feasibility Study of MEMS-Based Accelerator Grid Systems for Micro-Ion Engines: Electric Breakdown Characteristics

*Jet Propulsion Laboratory
California Institute of Technology
Pasadena, CA 91109*

Low-temperature (LTO) chemical vapor deposited (CVD) ~~silicon~~ **dioxide** was investigated for use as an insulator material in microfabricated ion engine accelerator grids. Both substrate (bulk) as well as surface breakdown experiments were performed. Oxide thicknesses for substrate breakdown tests ranged between 1 μm and 3.9 μm . Surface breakdowns were performed over gap distances ranging between 5 μm and 600 μm . Substrate breakdown strengths up to 600-700 V/ μm were measured, allowing for maximum stand-off voltages of 2500 V. A slight decrease in breakdown field strength for larger thicknesses was observed. Temperature effects on substrate breakdown field strengths do exist, however, are small. Only a 15% drop in breakdown field strength was noted at 400 C vs. strengths measured at room temperature. Surface breakdown field strengths ranged as high as 260 V/ μm , leading to a stand-off capability of 700 V over a 5 μm oxide film. Tests were performed to study the influence of silic

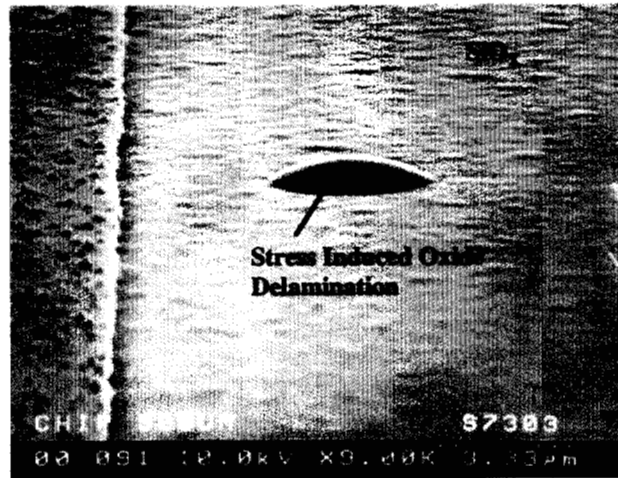
Fig. 27: Example of Stress-Induced Surface Delamination (approx. 3 μm dia.) on Oxide.

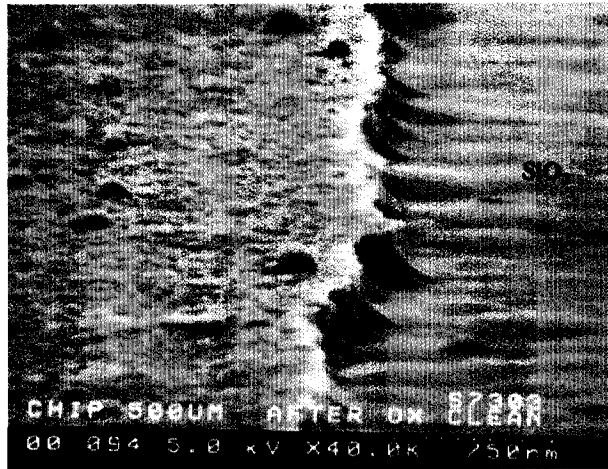
Fig.32: Close-up of Aluminum Pad Edge
